# Application of drone in detecting drain cover damages on road

Nguyen Dinh Hoang<sup>1</sup>, Ngo Khanh Hieu<sup>2,\*</sup>

## ABSTRACT

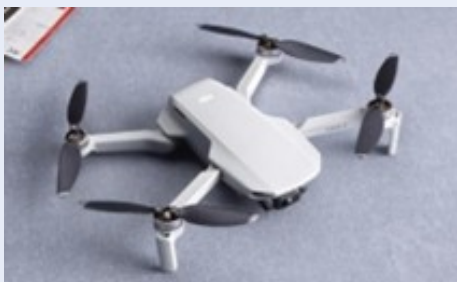
Figure 1: DJI Mini 2 drone

Currently on the internet there is no dataset taken by drone about damaged drain cover. So, we have to make our own dataset. We selected the DJI Mini 2 drone (Figure 1) for this task due to its compact size and high flexibility. And dataset is an extremely important part of deep learning, so we follow these requirements:

The specifications of the DJI Mini 2 drone are provided in Table 1 by the DJI company<sup>1</sup>. With flight altitude H, the focal length f, the sensor width Sw (the value of it is 6.26 mm in Table 1) and the image width Imw (the value of it is 4000 pixels in Table 1), we have the formula used to calculate required altitude is ground sampling distance GSD:

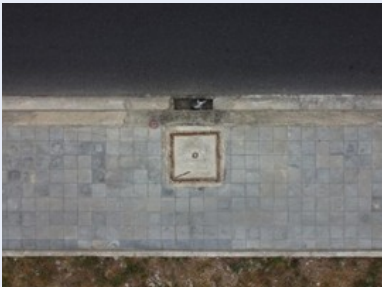
Figure 12: An example of hypothetical case of drain cover having a line crack

We used the hypothetical cases Figure 10, Figure 11 and Figure 12 above to test the model. Then we have the results as shown below:

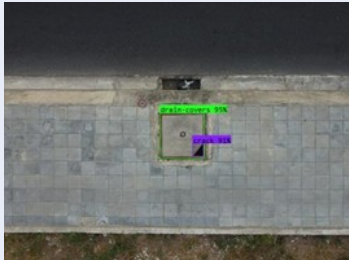
Figure 13: Detection result 1

From Figure 13, Figure 14, Figure 15 and Figure 16, we see that the model detects drain covers, their cracks and gully-gratings accurately with high confident score (more than 70%). The 4 edges of the bounding box almost coincide with the 4 edges of the drain covers and the gully- grating.

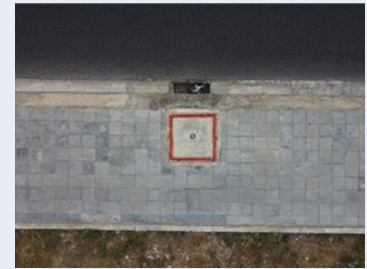
- *Step 1:* The Matlab code only reads the drain cover's bounding box information from a text file and overlay the bounding box mask on the image:

**Figure 22:** The drain cover is overlayed the bounding box mask
